Technical Bulletin

No: TCM–0018B–B
ITCM–0011B–B

Models RCS10, RCS10D, RCS10MP, RCS10MPS, RFS10SW2, RFS12MPS, RFS12SW2

Issue Complaint of “No heat” or ”Intermittent no heat”

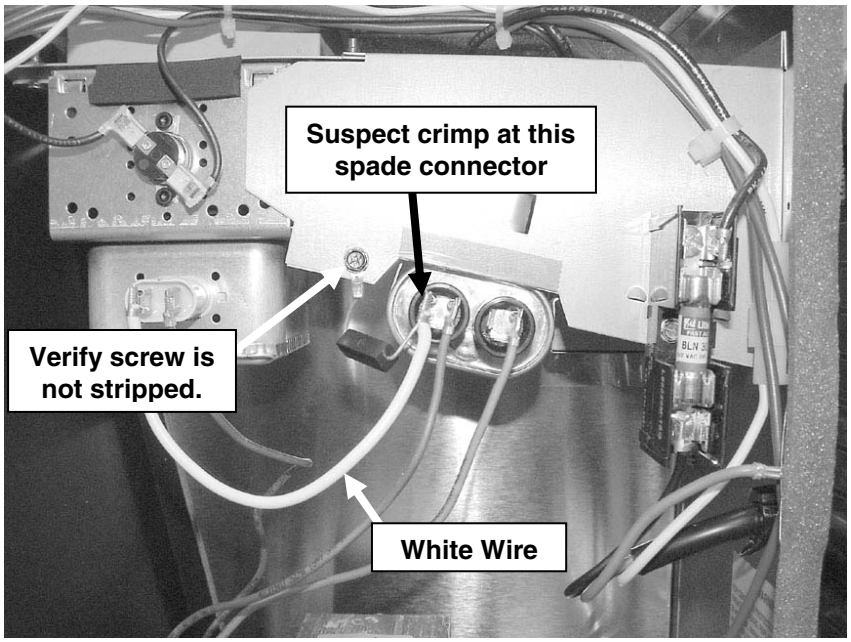
Action Amana has identified a potential reliability issue with the diode / HV wire assembly used on the following models and serials. Analysis has revealed a potential for a loose crimp on the spade connector that connects the diode / HV jumper wire to the capacitor. The suspect parts can be identified by a **white** jumper wire from the capacitor to the magnetron F terminal.

Repair is to install part number 12002548 Diode Kit. It consists of an individual diode and jumper wire.
